DEPARTMENT OF TRANSPORTATION**DIVISION OF ENGINEERING SERVICES**

Contract #: 04-0120F4Cty: SF/ALA Rte: 80 PM: 13.2/13.9File #: 69.28**WELDING INSPECTION REPORT****Resident Engineer:** Pursell, Gary**Address:** 333 Burma Road**City:** Oakland, CA 94607**Report No:** WIR-000747**Date Inspected:** 22-Oct-2007**Project Name:** SAS Superstructure**OSM Arrival Time:** 630**Prime Contractor:** American Bridge/Fluor Enterprises, a JV**OSM Departure Time:** 1500**Contractor:** Zhenhua Port Machinery Company, Ltd (ZPMC), Changxing Island **Location:** Shanghai, China**CWI Name:** Li Gang & She Zhi**CWI Present:** Yes No**Inspected CWI report:** Yes No N/A**Rod Oven in Use:** Yes No N/A**Electrode to specification:** Yes No N/A**Weld Procedures Followed:** Yes No N/A**Qualified Welders:** Yes No N/A**Verified Joint Fit-up:** Yes No N/A**Approved Drawings:** Yes No N/A**Approved WPS:** Yes No N/A**Delayed / Cancelled:** Yes No N/A**Bridge No:** 34-0006**Component:** Caltrans Mockup**Summary of Items Observed:**

Caltrans Quality Assurance (QA) Inspector, Mike Hasler was present to observe the fit up, welding and related activities associated with the fabricating of Caltrans Mock-up, 77M, 89M,

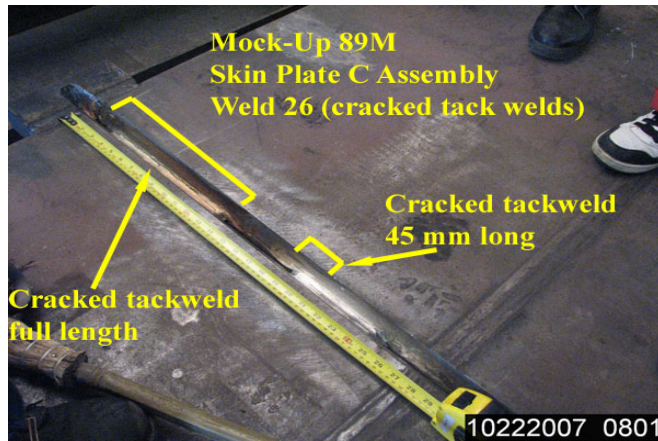
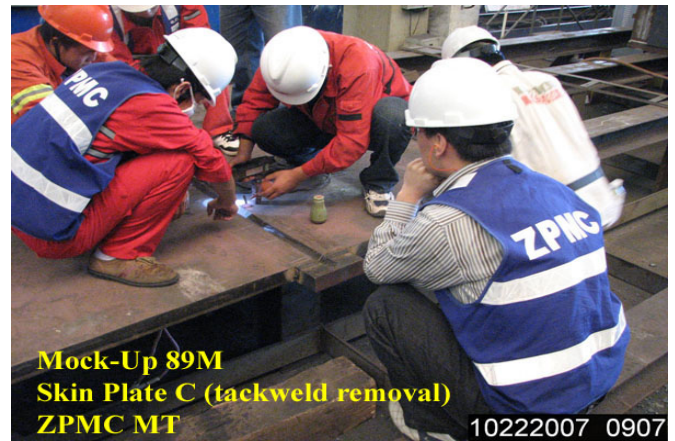
Mock-Up 89M, Skin Plate C (upper/lower): Caltrans QA Inspector observed two cracked tack welds at complete joint penetration (CJP) weld joint fitup, joining the upper and lower plate sections. ZPMC QC inspector, Mr. Ley Tao notified Caltrans QA Inspector that ZPMC observed cracked tack welds at the plate splice weld, weld number 26. Caltrans QA Inspector verified the cracked tack welds. Caltrans QA Inspector observed that one of the tack welds appeared to be cracked, full length of the weld and the other tack weld showed to be cracked, 45 mm in length. Caltrans QA Inspector witnessed the complete removal of the two tack welds, repair welding and the magnetic particle testing (MT) prior to welding and after welding. The MT testing was performed by ZPMC QC inspector, Mr. Cai Xinxin. The MT appeared to be in conformance with the contract specifications.

verified and identified as TL-508, classification E7018, specification AWS A5.1, and diameter 5.0 mm (.196 inch). Following digital pictures illustrates cracked tackwelds and ZPMC MT.

The repair welding was performed in accordance with WPS-B-P-2211-B-U3b, Revision 1. The welder is identified as Mr. Han Xiaofeng, welder stamp 054467. Caltrans QA Inspector observed ZPMC Quality Control (QC) Certified Welding Inspector (CWI) Mr. Xu Le Feng and Bureau Veritas inspector, Mr. Hou Jing Yao monitoring the repair welding. Caltrans QA Inspector measured current welding parameters at approximately 195 amps and 265 millimeters per minute (mm/min) travel speed. Preheat and interpass temperatures were verified during welding activities. The preheat temperature prior to the start of welding measures more than 110 Celsius (230 degree Fahrenheit) but less than 232 Celsius (450 degrees Fahrenheit) during maximum interpass temperature verification. SMAW consumable is

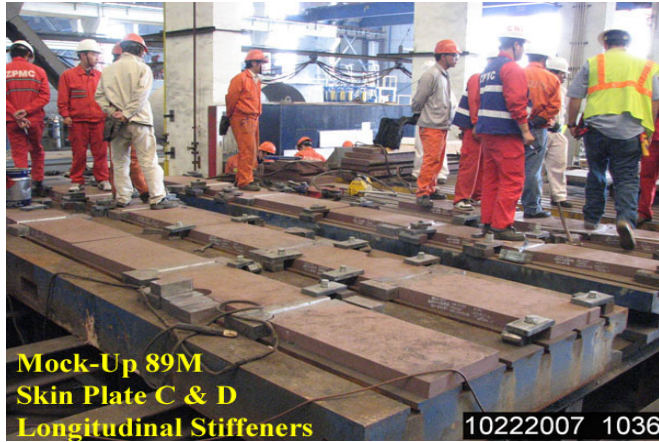
| <p>Mock-Up 89M, Skin Plate C/D, Longitudinal Stiffener Plates: Caltrans QA Inspector observed welder tack welding pre-assembled stiffener plates. The preassembled stiffener plates are identified as mp535A-1 to mp535B-1 to mp540-1, complete joint penetration (CJP) weld. Caltrans QA Inspector observed flux cored arc welding (FCAW) in progress. The welder is observed welding multi-pass tack welds in the flat position. The welder is identified as Mr. Han Xiaofeng, welder stamp 054467. The welder is using welding procedure specification WPS-B-P-2211-B-U3b, Revision 1. Caltrans QA Inspector observed ZPMC Quality Control (QC) Certified Welding Inspector (CWI) Mr. Sha Zhi and Bureau Veritas inspector, Mr. Li Gang monitoring welding activities at the workstation. Caltrans QA Inspector measured current welding parameters at approximately 200 amps and 275 millimeters per minute (mm/min) travel speed. Preheat and interpass temperatures were verified during welding activities. The preheat temperature prior to the start of welding measures more than 110 Celsius (230 degree Fahrenheit) but less than 232 Celsius (450 degrees Fahrenheit) during maximum interpass temperature verification. SMAW consumable is verified and identified as TL-508, classification E7018, specification AWS A5.1, and diameter 5.0 mm (.196 inch). Following digital picture illustrates welding in progress.</p> | | | | |
